UNIVERSITY OF  
ALBERTA

# Asbestos Management Program

Facilities and Operations

## **Asbestos Management Program**

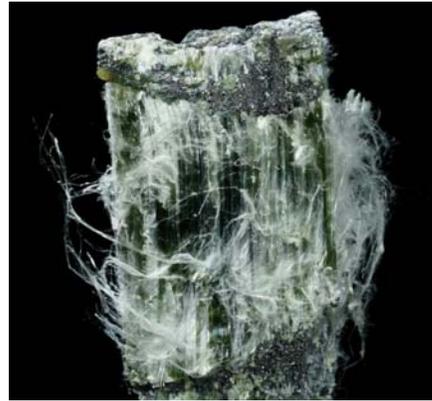
Asbestos is a naturally occurring, strong mineral fibre that is resistant to heat and many chemicals. It differs from other minerals because of its fibrous, crystalline structure that can be separated into flexible fibres.

Chrysotile asbestos (mineral form)

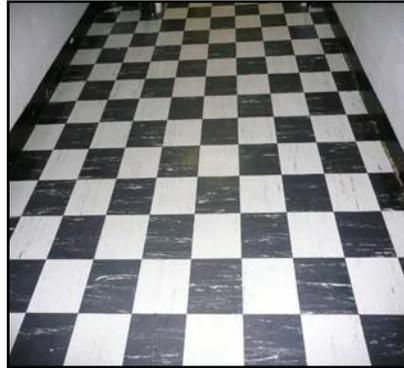
12"x12" and 9"x9" tiles have been generally found to contain 1% to 10% Chrysotile asbestos. The asbestos fibres in VATs are tightly bound into the matrix of the tile and are considered non-friable.

**Precautions:** Do not cut or break dry tiles. Only trained University staff may remove less than 10 square feet with hand tools using low risk procedures specific to this activity.

Vinyl asbestos tile (VAT)

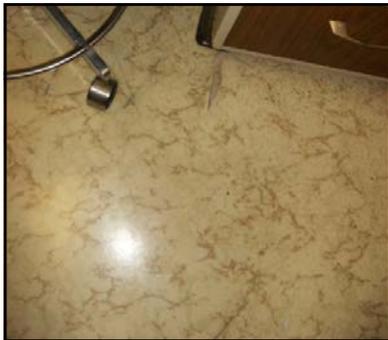
Sheet vinyl flooring

The paper backing on the underside of sheet vinyl flooring may contain friable asbestos. The paper backing has been generally found to contain 50% to 90% Chrysotile asbestos.

**Precautions:** Do not cut dry sheet vinyl flooring. Safe work procedures are required to repair or remove this type of flooring.

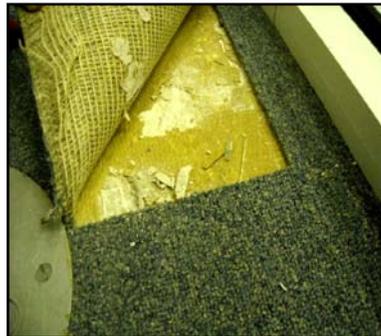
Floor leveling compound (FLC) is generally found under tile, sheet flooring and carpet. It may contain 1% to 75% Chrysotile asbestos and is generally grey, white or brown in both a fibrous or cementitious form. In some areas, there may be VAT and FLC under the carpet or multiple layers of VAT and FLC in one room.

White FLC under carpet

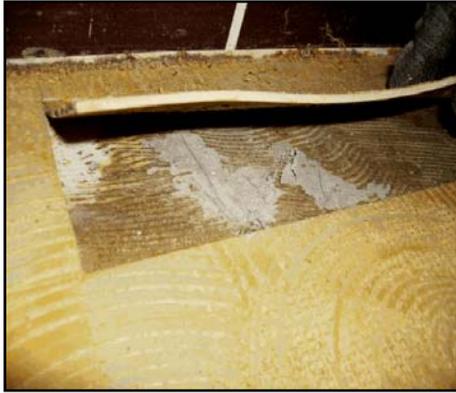
Grey FLC under floor tiles

**Precautions:** The flooring must be checked for floor leveling compound **prior** to removal of the flooring. This applies to carpet and floor tile removal. Sometimes FLC may be present under mastic or paint. If repair or maintenance work may cause disturbance of this material, contact your supervisor.

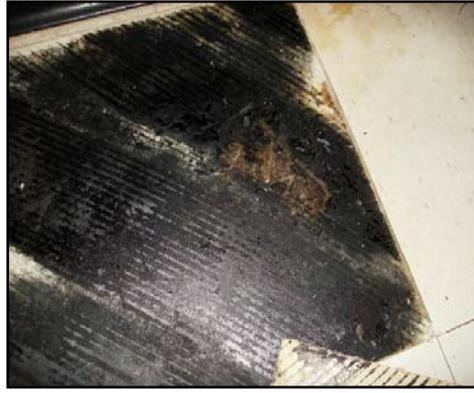
Mastic may also be present under VAT. It contains 1% to 10% Chrysotile asbestos. It is non-friable.

Black mastic under vinyl floor tiles

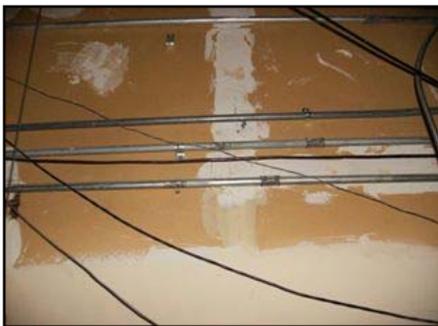
Drywall joint compound is often present along drywall seams, over screws, over steel corner beads and sometimes as a thin layer on the drywall. The asbestos content in joint compounds has generally been found to be 1% to 10% Chrysotile asbestos. Asbestos containing dust may be generated during wall repair or demolition.

Drywall joint compound

**Precautions:** Use hand tools and wet methods to minimize dust. If a drill is used, it must have a dust collection device fitted with a HEPA filter. Trained University staff may undertake only minor repair and/or maintenance work using safe work procedures specific to this activity.

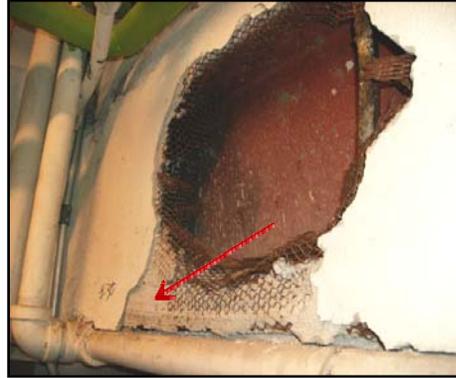
Asbestos may be present in all layers of plaster but is typically found in the coarse "base" or "scratch coat" layer of plaster (beige or grey in color) typically on metal or wood lathe. The asbestos content has generally been found to be 1% to 5% Chrysotile and/or Actinolite asbestos. Asbestos containing dust may be generated during wall repair or demolition.

Beige "scratch coat" plaster

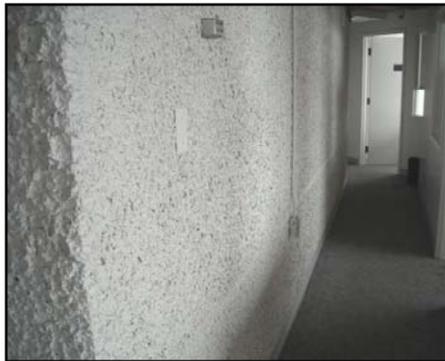
Decorative plaster (spray-applied)

Decorative plaster or "cement plaster" is mixed with cement and is either spray-applied or troweled. The asbestos content has generally been found to be 1% to 5% Chrysotile asbestos. Asbestos containing dust may be generated during wall repair or demolition.

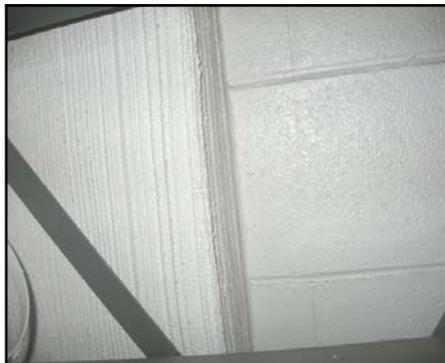
Decorative plaster (troweled)

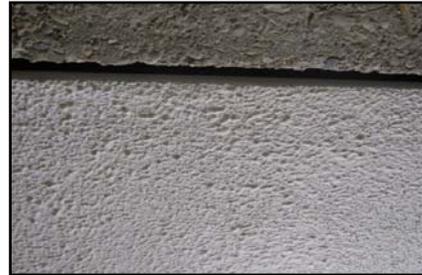
Stippled and textured ceiling finishes have been found to contain 1% to 50% Chrysotile asbestos. Stipple coat is typically applied as a thin, non-friable, layer on plaster or concrete whereas texture coat is applied as a thicker, more friable, layer.

Ceiling stipple coat

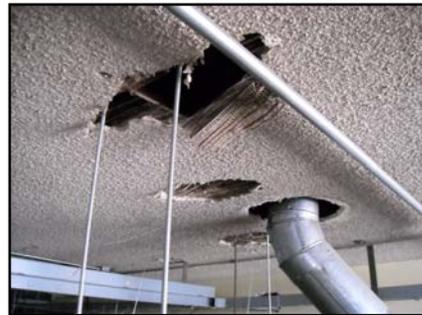
Ceiling texture coat

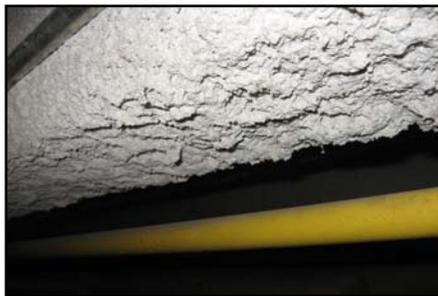
Spray-applied thermal/acoustic insulation is generally found in mechanical rooms and sometimes above suspended ceilings, on beams, metal decks, joists and columns. This type of insulation may contain 1% to 90% Chrysotile or Amosite asbestos and is very friable. Most asbestos containing spray-applied fireproofing insulation on campus has been removed or replaced with non-asbestos materials. If in doubt, request to have a sample taken for clarification.

Spray-applied thermal insulation (fireproofing)

**Precautions:** Do not disturb (scrape, drill or hammer into) surfaces covered with this material. If installing small attachments to a surface covered with this material, contact your supervisor.

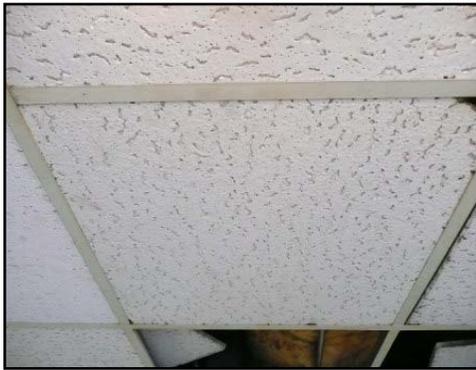
T-Bar ceiling tiles may contain 1% to 25% Chrysotile or Amosite asbestos. Asbestos ceiling tiles range from a wide variety of sizes including 1'x1', 2'x2', 2'x4', and 1.5'x6'. There may be asbestos and non-asbestos tiles in the same area. The only way to know for sure is by having the tiles tested. Generally, ceiling tiles with deep fissures and a red backing are more likely to contain asbestos. The majority of asbestos containing ceiling tiles have been removed from campus and replaced with non-asbestos materials.

T-Bar ceiling tile

**Precautions:** Always lift ceiling tiles gently and slide over onto the next tile. Use low-risk safe work procedures to remove or move 10 square feet or less of ceiling tiles that may contain asbestos. Never break asbestos ceiling tiles during removal. For work involving ceiling tile removal in areas greater than 10

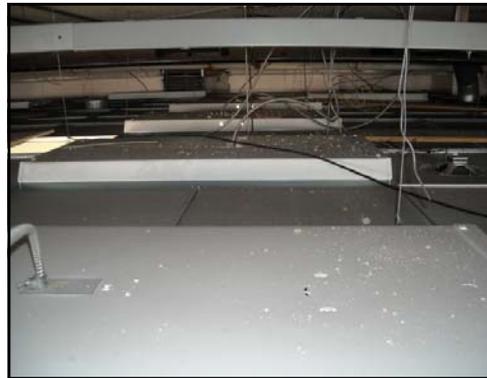
ACM debris may be found on top of ceiling tiles in areas that have spray-applied fireproofing, ceiling stipple/texture finishes or asbestos pipe insulation.

**Precautions:** Use extreme care when lifting ceiling tiles that may have ACM debris. Use low-risk safe work procedures specific to accessing ceiling spaces that may contain ACM.

Texture coat debris on ceiling tiles & light fixtures

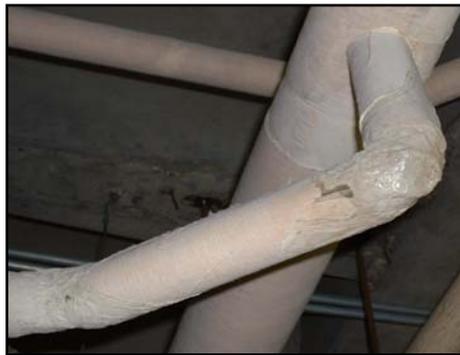
Pipe fitting insulation or “mud” includes a mixture of asbestos and cement on pipe elbows, joints, valves, reducers, hangers, etc. The mud is usually found wrapped with painted or non-painted canvas, but occasionally as bare mud. Mud may also be found applied on joints as a thin layer over fibreglass insulation and wrapped with canvas. This type of material usually contains 5% to 90% Chrysotile asbestos. It may occasionally be mixed with Amosite or Crocidolite.

Pipe elbow mud wrapped with non-painted

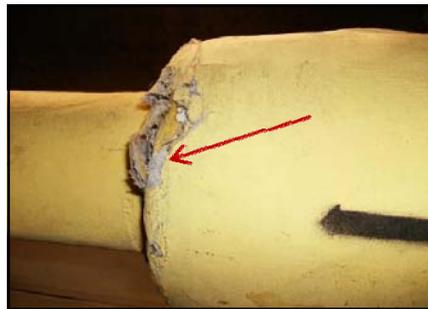
Mud on fibreglass adjacent to valve

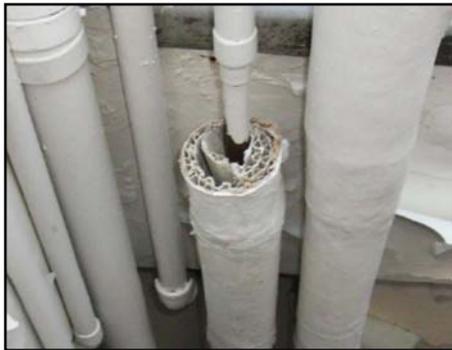
Corrugated “Aircell” insulation

Aircell looks like corrugated cardboard insulation and is found on straight lengths of pipes. It usually contains 25% to 90% Chrysotile asbestos. This type of insulation is friable.

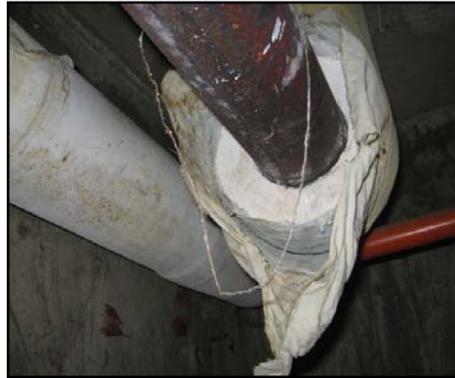
Block Insulation may be found on pipe runs and elbows. It is preformed as two half circle pieces that fit around a pipe. The two pieces are held together with either canvas and/or wire. It is generally found on high temperature steam lines and contains 50% to 90% Amosite and/or Chrysotile asbestos.

White solid block insulation

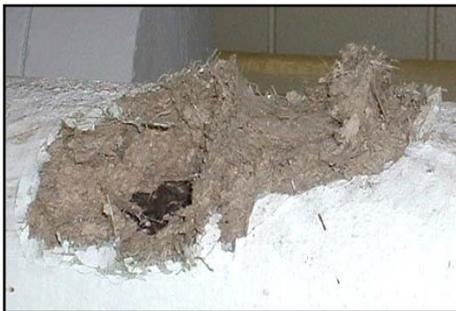
Brown solid fibrous insulation

Fibrous pipe insulation is another form of asbestos insulation that was used on pipe runs and elbows on high temperature steam lines. It contains 90% Amosite asbestos. It is very friable.

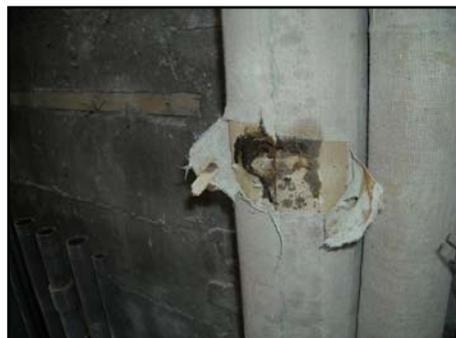
Asbestos containing construction paper is sometimes found on pipe runs covering layers of felt and fibreglass and wrapped with canvas. It typically contains 1% to 5% Chrysotile asbestos.

White construction paper insulation

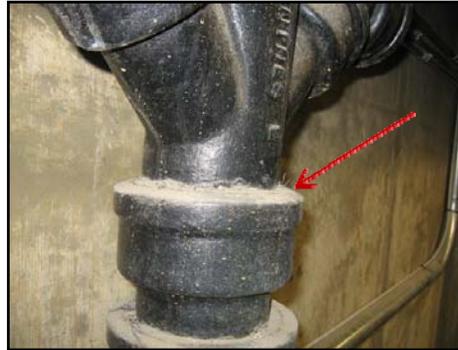
Oakum-type packing at cast iron pipe joints may contain ACM. It has been found to contain 1% to 75% Amosite or Chrysotile asbestos.

Joint packing on a cast iron pipe

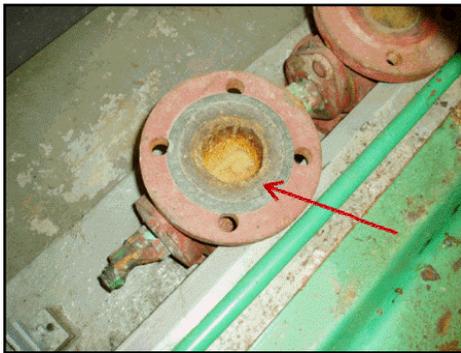
Pipe gasket

Gaskets at flanged pipe joints have been found to contain 50% to 75% Chrysotile asbestos. This material becomes very friable if disturbed or damaged.

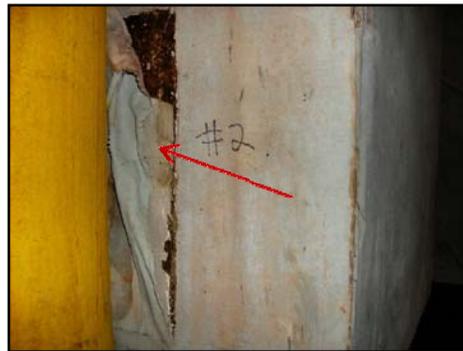
Parging cement is typically found on ducting as a thin layer between canvas and layers of felt, foil and/or fibreglass. It contains 5% to 90% Chrysotile asbestos.

Parging cement on duct

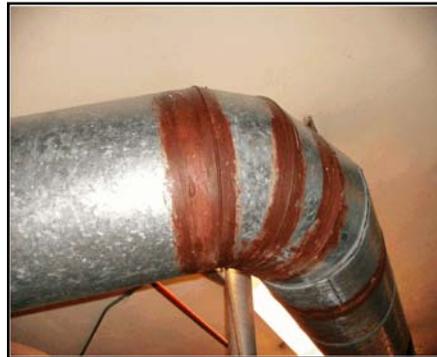
Mastic may be found along duct joints on bare ducts or on ducts covered with insulation. Asbestos has been found in various colors of mastics including red, black and yellow. It is a non-friable material. It has been found to contain 1% to 10% Chrysotile asbestos. Not all mastics contain asbestos. As a result, testing should be conducted prior to impacting the material.

**Precautions:** Do not cut into the mastic. The most effective way to abate this material is to wrap the mastic, cut the duct on either side of the mastic and dispose of the whole piece of duct with the mastic as asbestos waste.

Red duct mastic

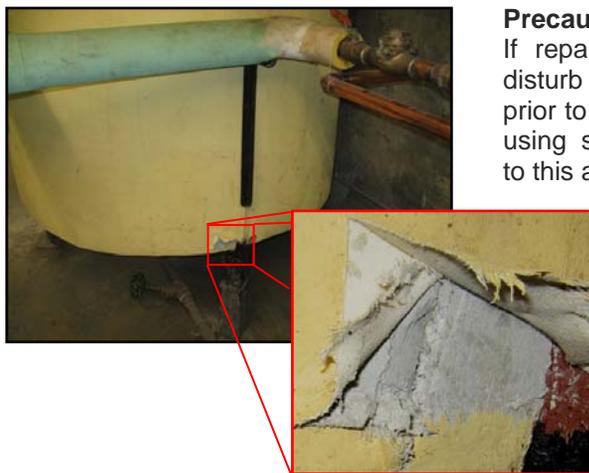
Parging cement is also found on tanks, vessels, boilers, etc. as either a layer between canvas and felt/fibreglass or as a thicker layer on wire lathe and covered with canvas. It contains 5% to 90% Chrysotile asbestos.

Parging cement on a tank

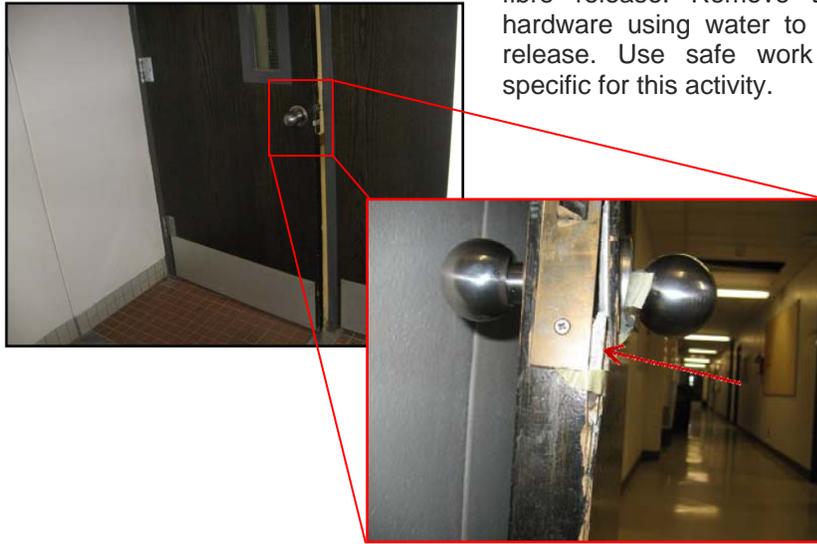
The interior filler of certain fire doors contain asbestos. It may be in a block or sheet form. It has been found to contain 50% to 90% Chrysotile and/or Amosite asbestos. The filler may be exposed when removing hardware or when the door is damaged. This material is very friable.

Fire door interior (white sheets of asbestos)

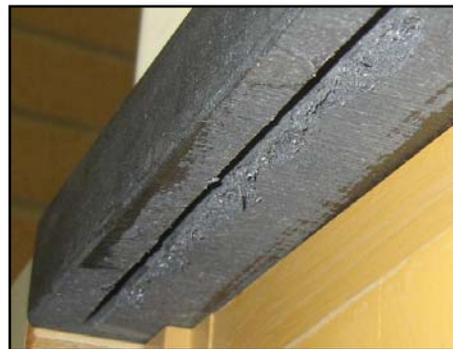
Countertops are located throughout campus buildings and are typically dark grey or green in color. This material is non-friable. It contains 5% to 50% Chrysotile asbestos.

Underside of countertop

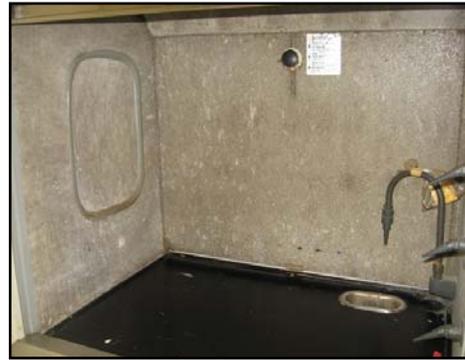
Cement board or “Transite” is a mixture of cement and asbestos. Due to its high resistance to heat and corrosion, cement board has been used in a wide range of applications. Examples include fume hood linings, flammable and chemical storage cabinets, roof and siding panels, perimeter heat register panels and wall and ceiling panels. It has been found to contain 5% to 90% Chrysotile asbestos. The material may also be painted.

Transite fume hood lining

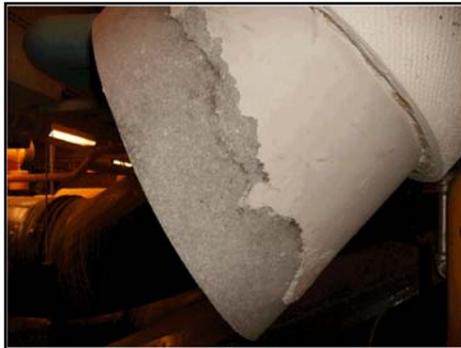
Transite may also be found in the form of piping or ducting. Transite ducts are used to exhaust fume hoods and are generally found to contain 5% to 50% Crocidolite and/or Chrysotile asbestos. Transite pipes generally contain 25% to 50% Chrysotile asbestos.

Transite duct

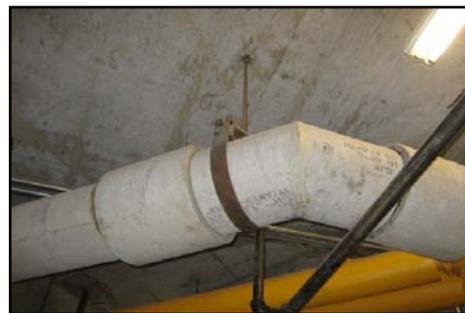
Transite pipe

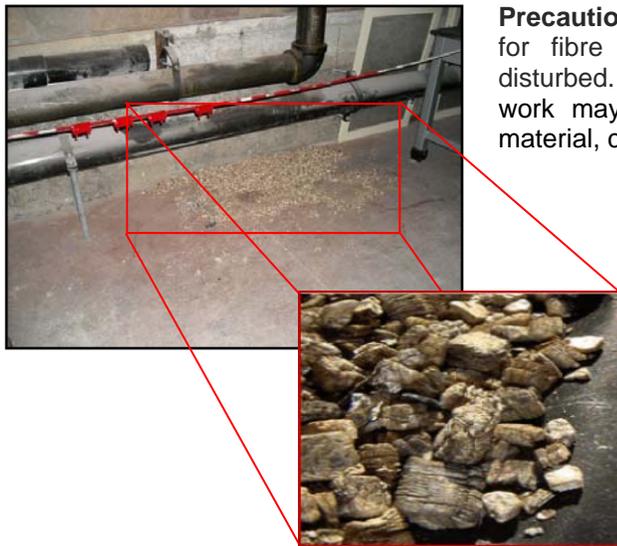
Some vermiculite insulation may be contaminated with asbestos. This type of vermiculite is known as Zonolite® and is typically contaminated with <1% Anthophyllite or Tremolite asbestos. Although the material is contaminated with trace amounts of asbestos, it is very friable and disturbing it can produce high levels of airborne asbestos fibres. Zonolite® may be found as loose insulation in an attic space or within the cavity of exterior cinder block walls. It may be brown or grey in color.

Vermiculite debris from a cinder block wall cavity
